Archaeological Assessment Report No. 2,
Sigginstown Castle, Sigginstown, Co. Wexford.

Archaeological Licence: 16E0519
Planning ref: 20180037
ITM 706253 607084
RMP ref: WX053-001 & WX053-001001

Clients:
Liz & Gordon Jones

By:
Catherine McLoughlin
August 2018

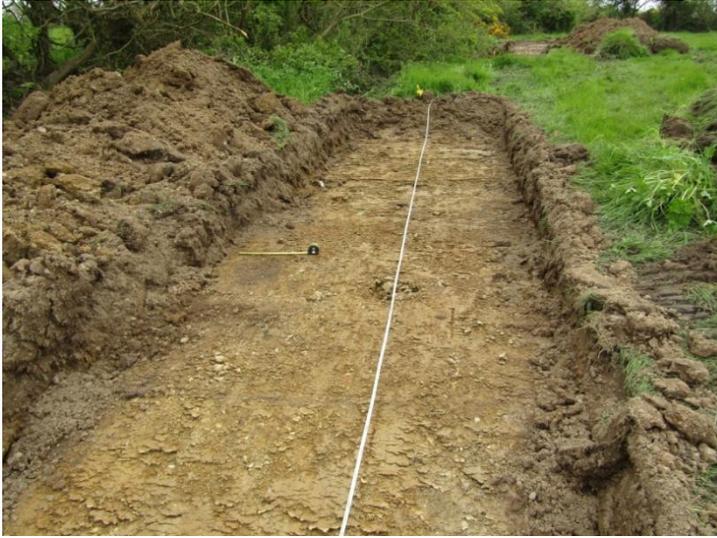
C102 Possible pit or posthole contained charcoal rich fill. 0.15m in diameter.

Fig. 10 Trench 1 showing C102, looking W

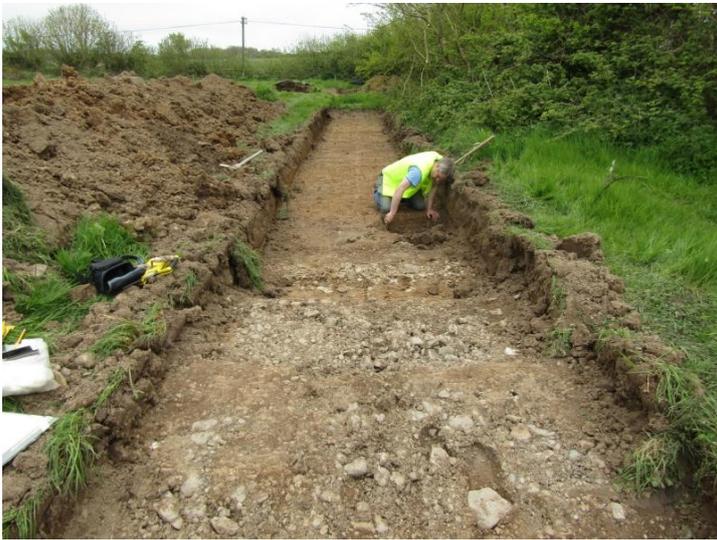
C103 3m wide metallised surface located 0.1-0.15m below the present ground surface. Surface composed of compacted small stones. No artefacts retrieved from uncovered portion.

C104 Gully located immediately to east of C103. 1.3m wide x 0.3m deep. Located 0.2 below present ground surface.

Fig. 11 Metalled surface C103 and gully C104 in Tr 2, looking E

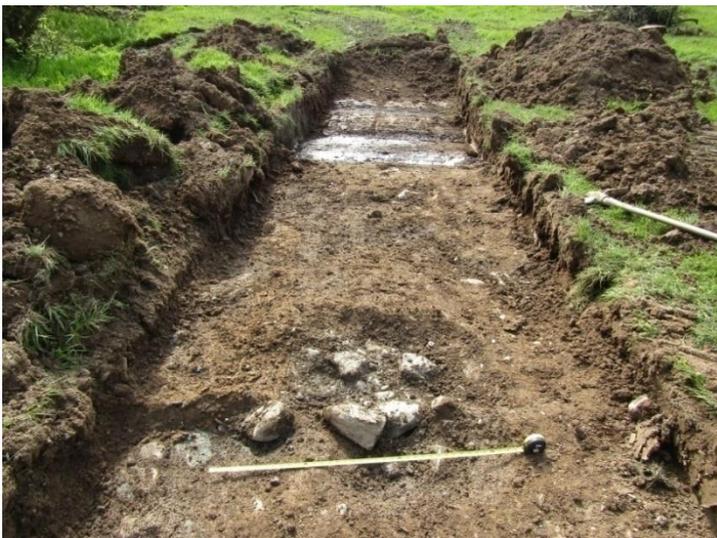
- C105 Very waterlogged area which filled with water on excavation. It was unclear whether this is a ditch, but it probably is. Appeared for a length of 5m with brown silty clay and charcoal flecking.
- C106 Stoney surface which may be the remains of a building.
- C107 Waterlogged area which filled with water on excavation. Possibly a ditch.
- C108 Shallow gully.
- C109 Shallow gully.
- C110 Shallow gully.

Fig. 12 C106 in Tr 3, looking W

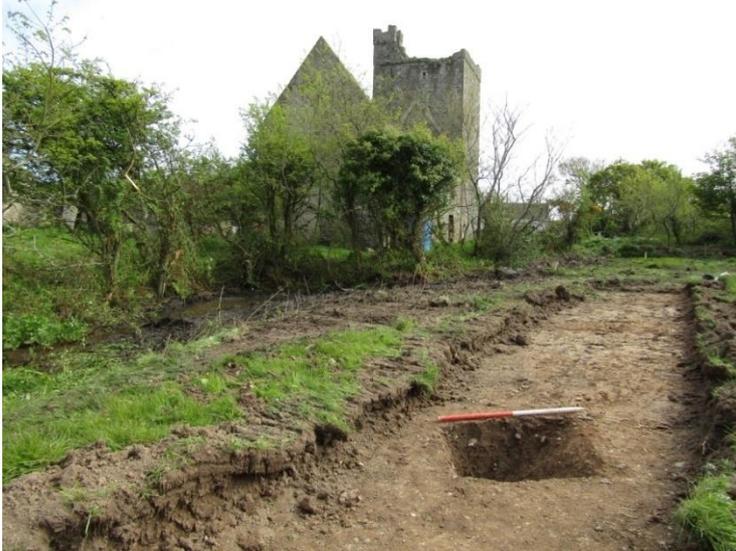
- C111 Large ditch apparent at a depth of 0.23-0.3m below present ground level. A small section was excavated at the edge to a depth of 0.5m. Not bottomed.

Fig. 13 C111 in Tr 4, looking SE

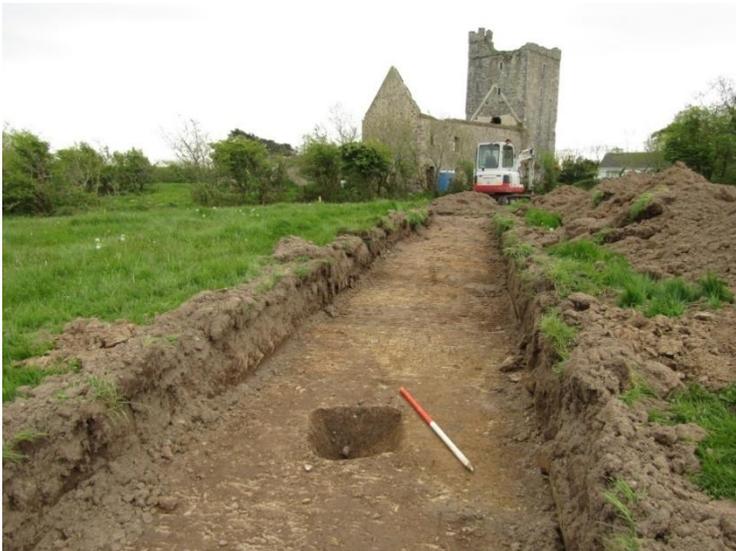
- C112 Furrow.
- C113 Gully.
- C114 Ditch, measuring c. 3m in width, associated with ditch C115 which either cuts or is cut by it. Filled by mid brown clay.
- C115 Ditch, measuring c.4m in width, associated with ditch C114 which either cuts or is cut by it. Filled by mid brown clay. Contained medieval pottery.

Fig. 14 C114 in Tr 5 looking SE

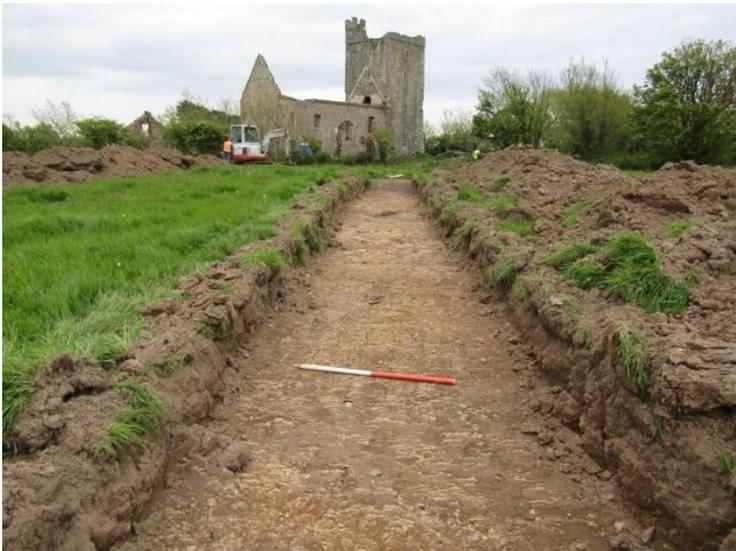
- C116 Possible ditch? Deep area of soil at south end of trench, contained early post-med pottery.
- C117 Furrow, contained 17th century pottery.
- C118 Gully 1.2m wide.
- C119 Feature unclear, possible ditch, 1.3m wide. Contained 17th century pottery.

Fig. 15 Tr 6 looking SE

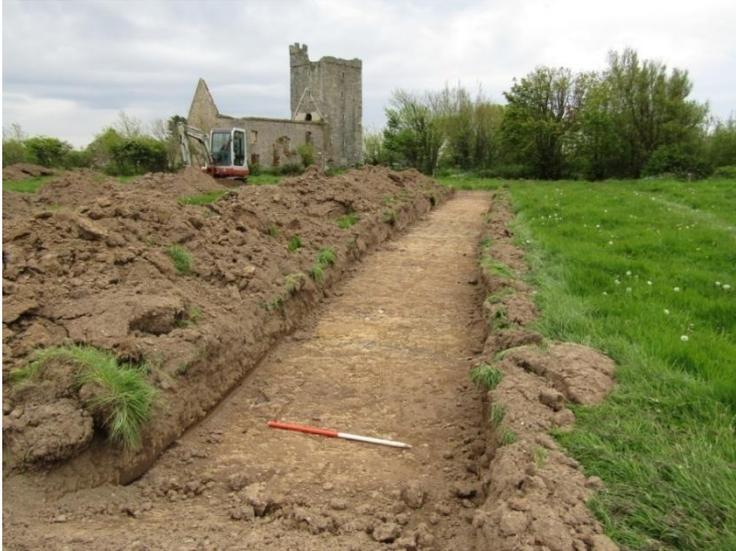
- C120 Possible ditch.
- C121 Furrow.
- C116 Possibly a continuation of C116 in Trench 6.
- C122 Furrow. Contained glazed pottery.
- C123 Possible ditch.

Fig. 16 Tr 7 looking SE

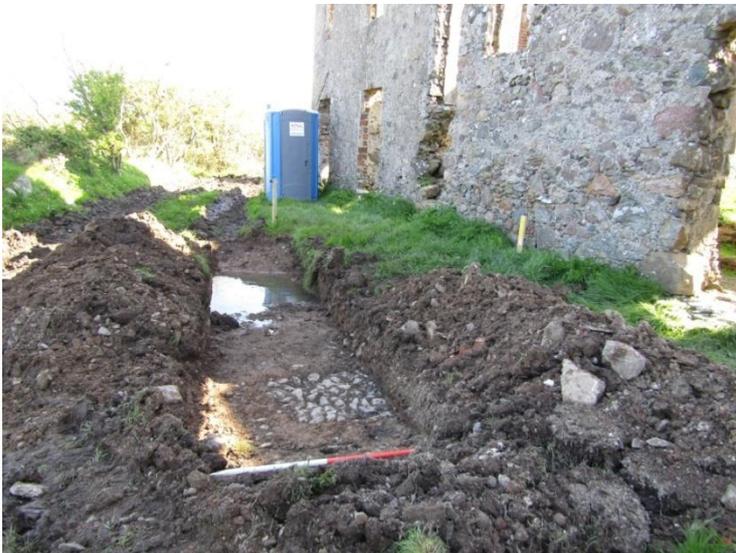
- C124 Redeposited clay with a depth of 0.1-0.2m underlying topsoil and overlying cobbled surface C125.
- C125 Cobbled surface, partially exposed beneath clay C124. Contained base of small glass bottle, 17th/18th century.
- C126 Possible pit at north end of Trench 8. Contained dark charcoal fill but became very wet on excavation so could not be investigated further.

Fig. 17 Cobbled surface C125 in Tr 8, looking N

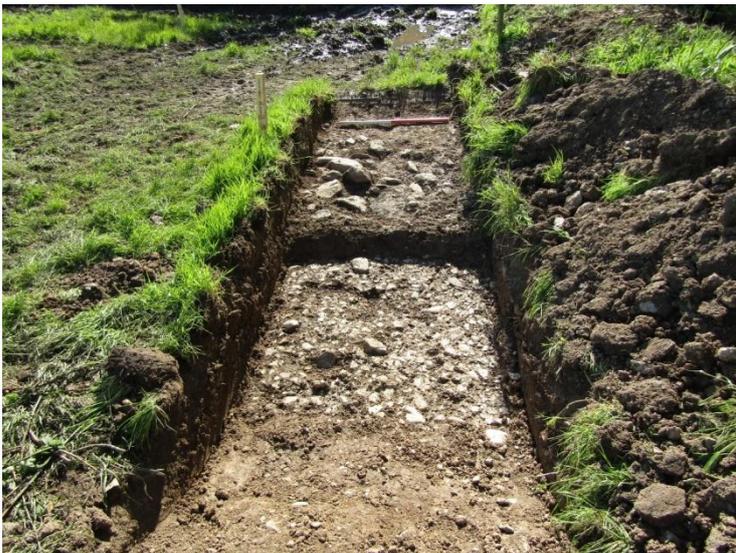
- C127 Layer of medium sized stones bedded in clay beneath 0.3m of topsoil. Overlay C128. Contained glazed ridge tile.

C128 Fine metalled surface at 0.5m deep. Contained glazed pottery.

Fig. 18 Surfaces C127 & C128 in Tr 9, looking E

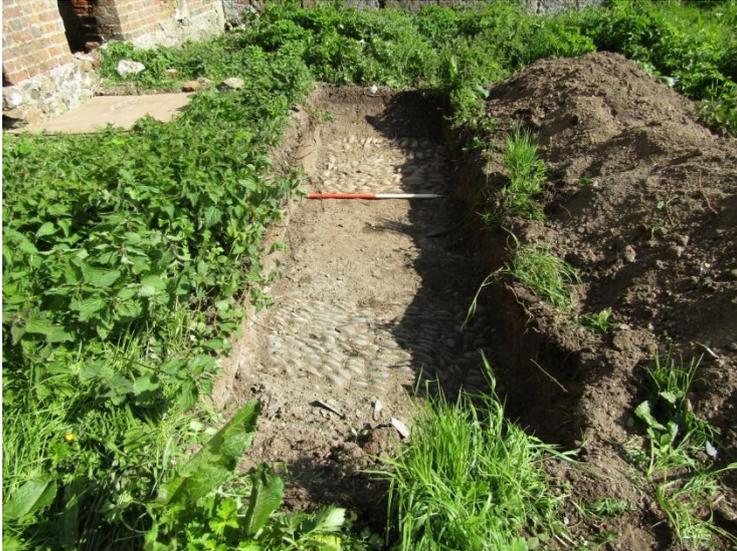
C129 Cobbled surface located 0.4m below present ground level.

Fig. 19 Cobbled surface C129 in Tr 10, looking N

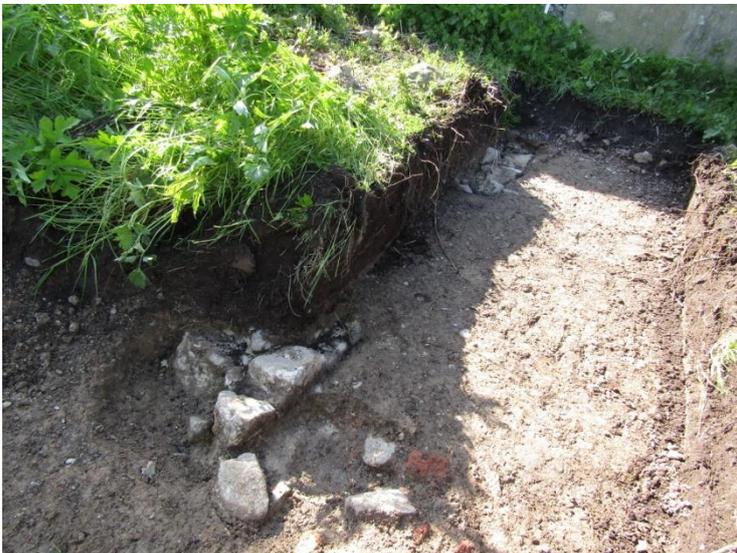
C131 Lime-mortared stone wall exposed for a length of 1.2m, underlay C130.

Fig. 20 Wall C131 in Tr 11, looking S

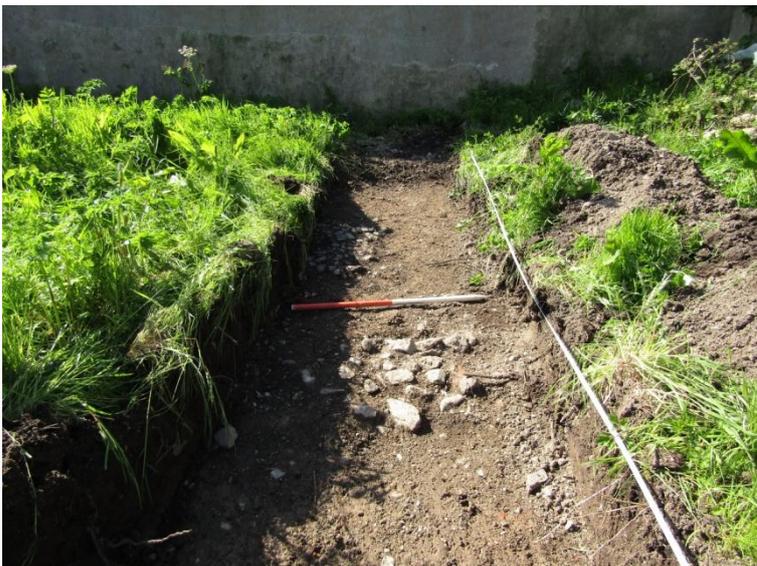
C133 Layer of cobbles set in clay at 0.2-0.25m below present ground level.

C134 Layer of rougher cobbles to the north of C133.

Fig. 21 Surfaces C133 & C134 in Tr 12 looking S

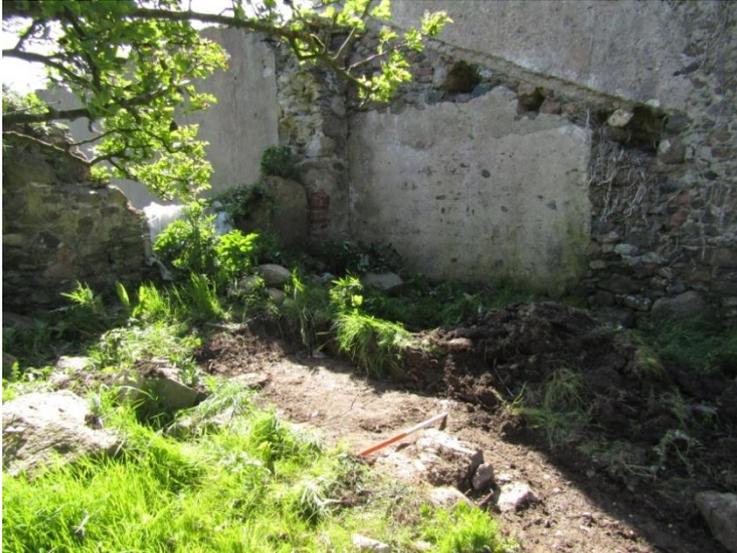
C135 0.7m wide clay bonded wall located immediately below the topsoil.

Fig. 22 Wall C135 in Tr 13, looking SE

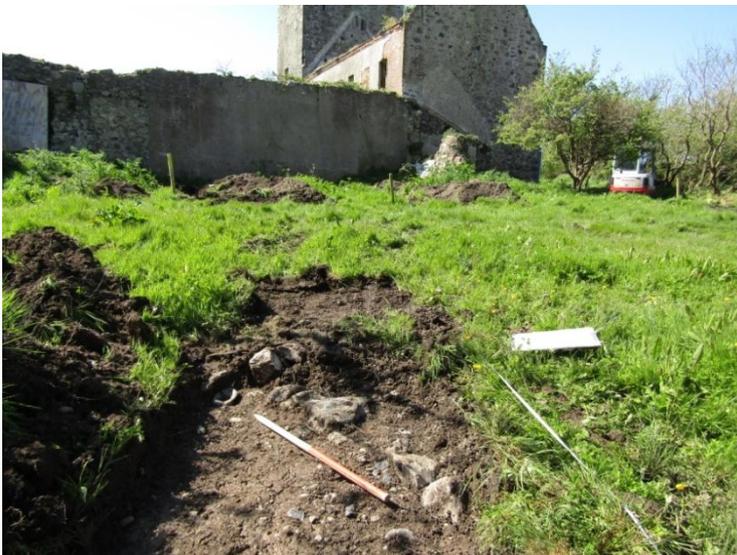
C136 Length of wall uncovered immediately underneath topsoil.

Fig. 23 Wall C136 in Tr 14, looking S

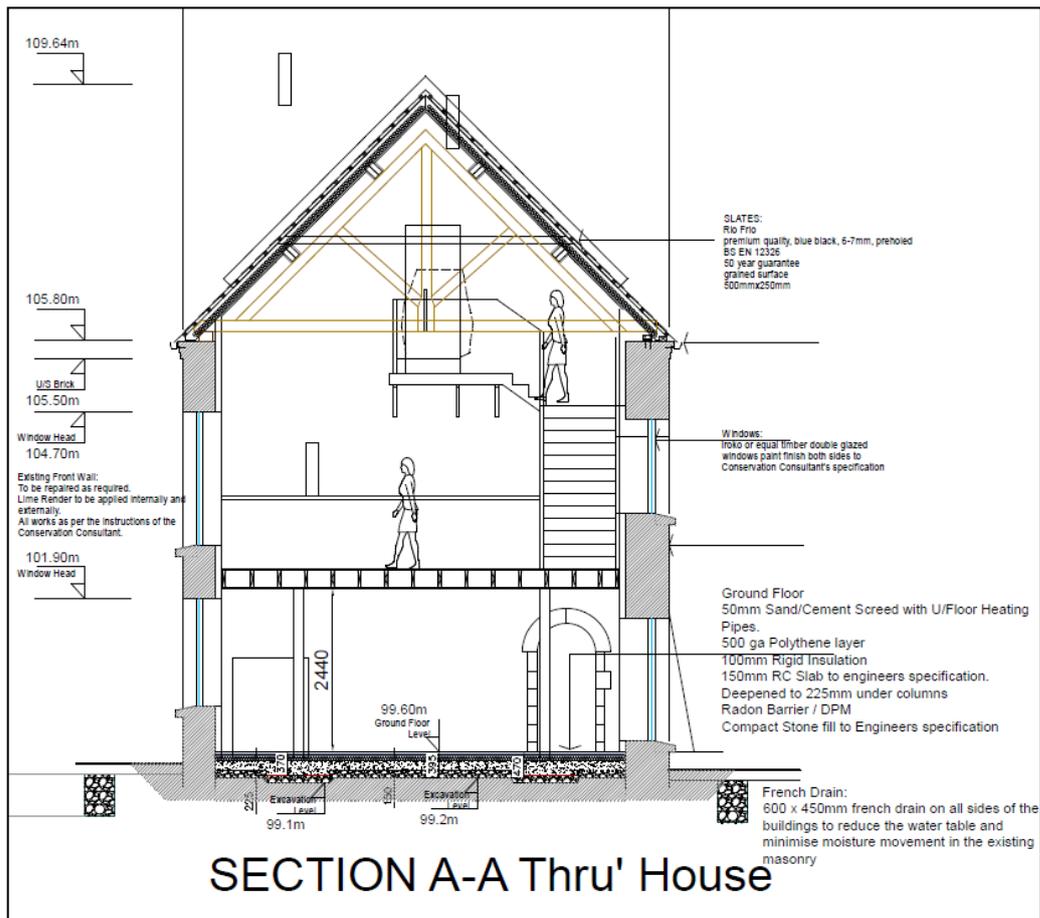
Fig. 32 Floor detail of attached house

- Attached house – insertion of new ground floor will require the excavation of up to 450mm of the current floor surface (fig. 30 & 32). The attached house contains internal walls and fireplace bases which will be impacted on. Underpinning of the existing walls is not proposed at this time however it must be noted that plans often change at construction stage and that underpinning may be necessary at a later stage.

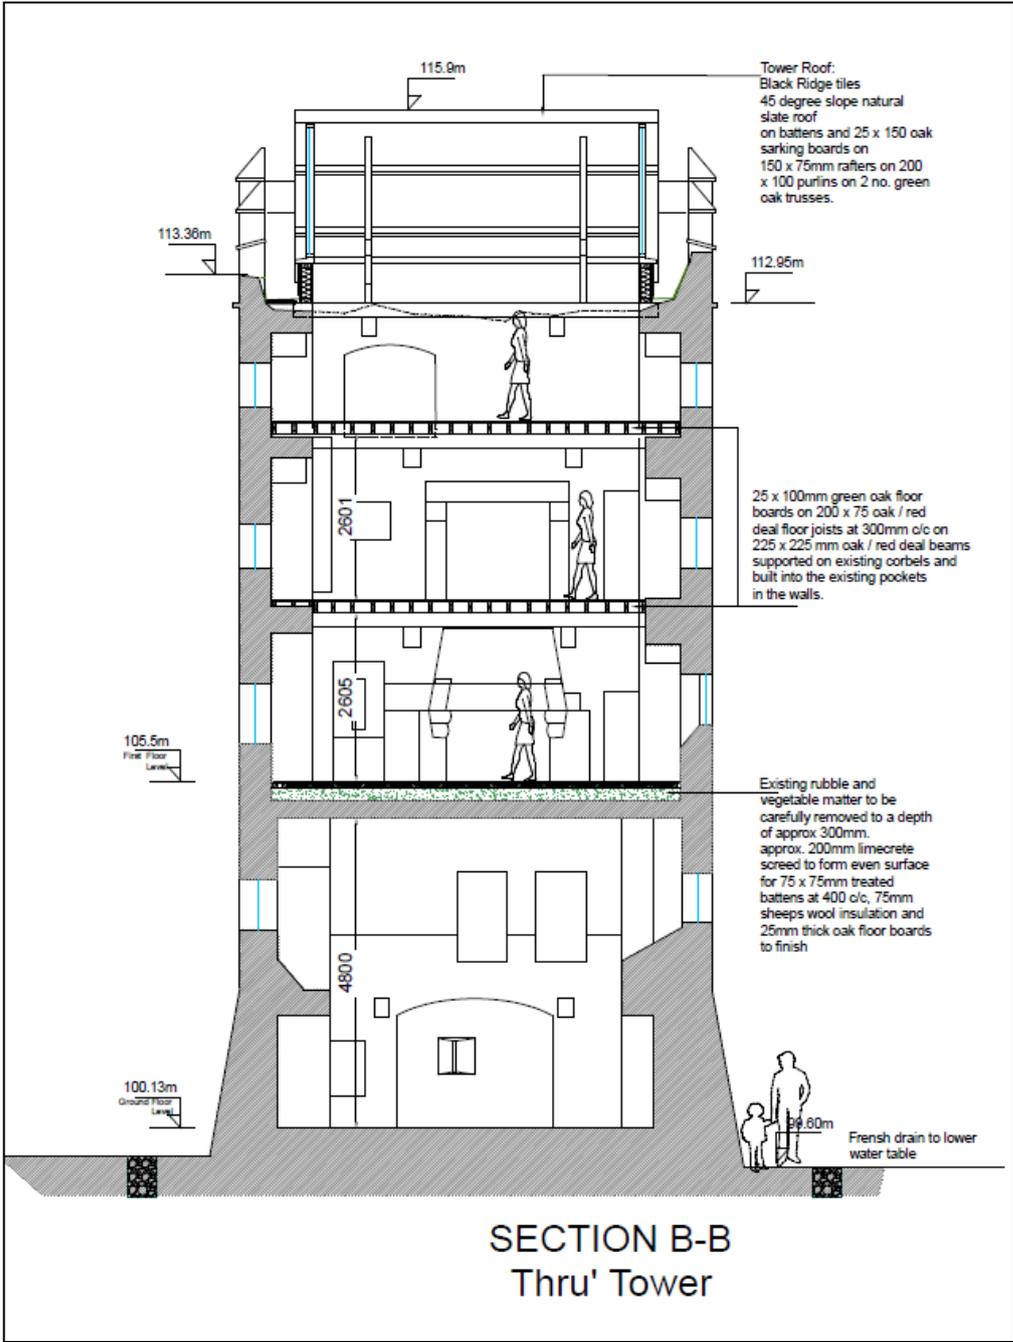
Fig. 33 Section through tower-house showing proposed floors

- Tower-house – insertion of new ground floor will require the excavation of c.400mm of the current ground floor surface and 250mm of the floor over the overhead vault (fig. 33).
