Preliminary Archaeological Assessment Report,  
Sigginstown Castle, Sigginstown, Co. Wexford.

Archaeological Licence: 16E0519  
ITM 706247 607073

Clients:  
Liz & Gordon Jones

By:  
Catherine McLoughlin  
December 2016

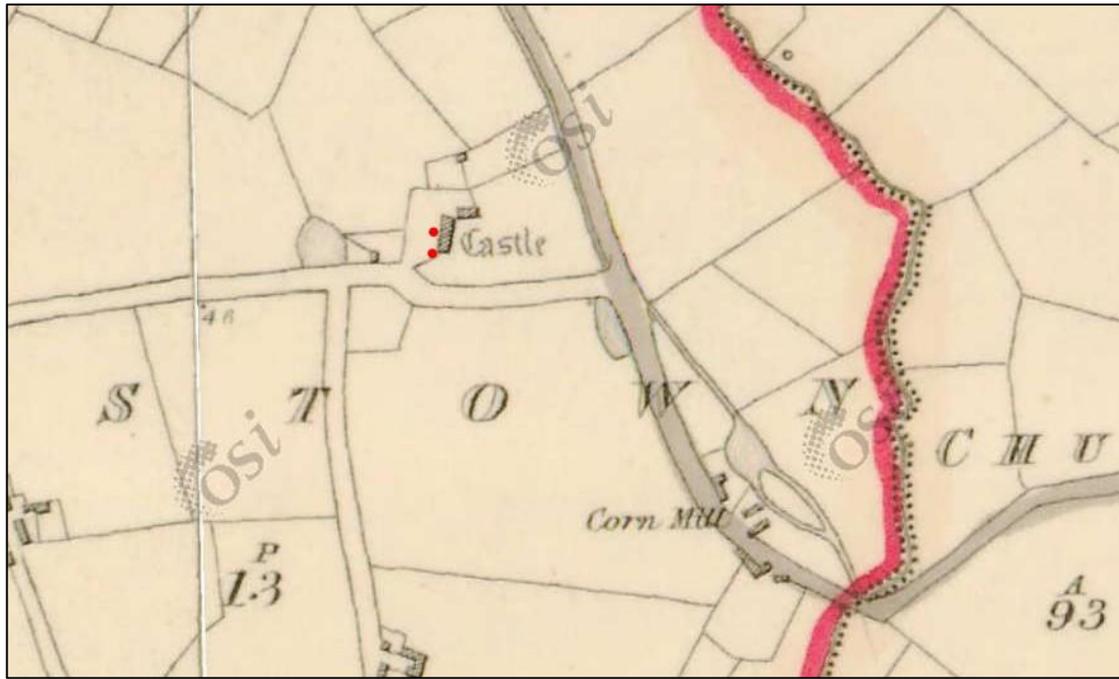
Fig. 2 Location of Sigginstown Castle within extract from 1840 OS map

The earliest accurately dated map of Wexford is the first edition Ordnance Survey map which dates to 1840 (fig. 2). In 1840 the castle and house are shown and marked on the map as one building. There is another building set at a right angle to the house, this an 'agricultural building' which still exists on the site today. The buildings are set within an overall pattern of small rectangular fields. There is no evidence of a bawn.

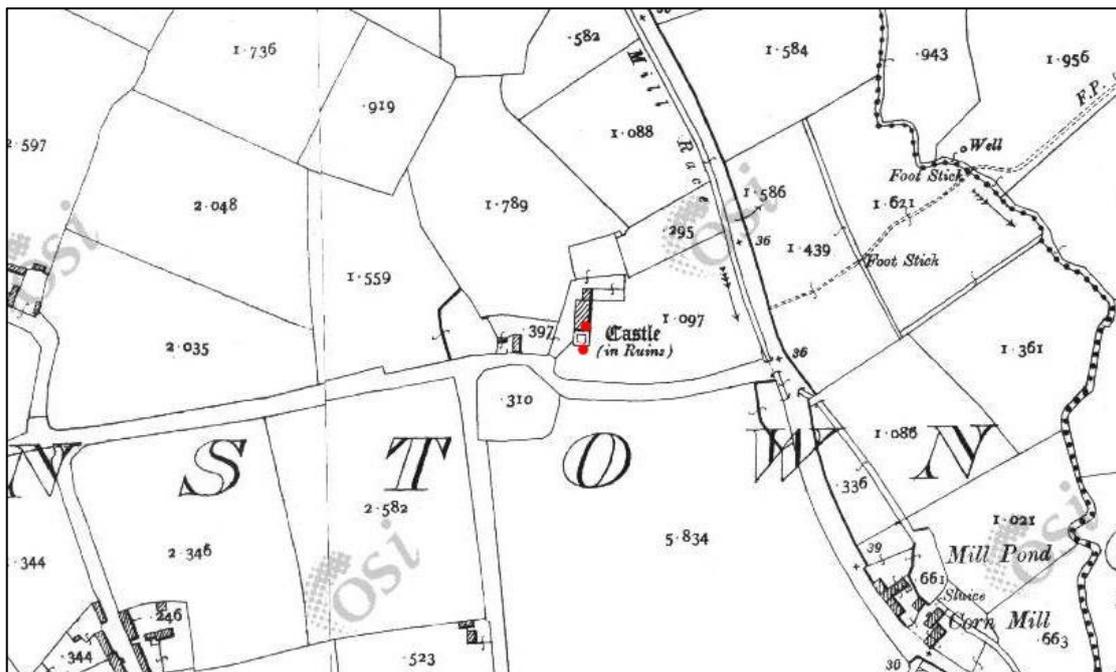
Fig. 3 Location of Sigginstown Castle within extract from 1903 OS map

By the time of the compilation of the second edition Ordnance Survey map in c.1903 (fig. 3) there had been little change to the arrangement of the fields, however the field boundary immediately to the west of the castle had been moved slightly and an additional building connected the north end of the house with the agricultural building.

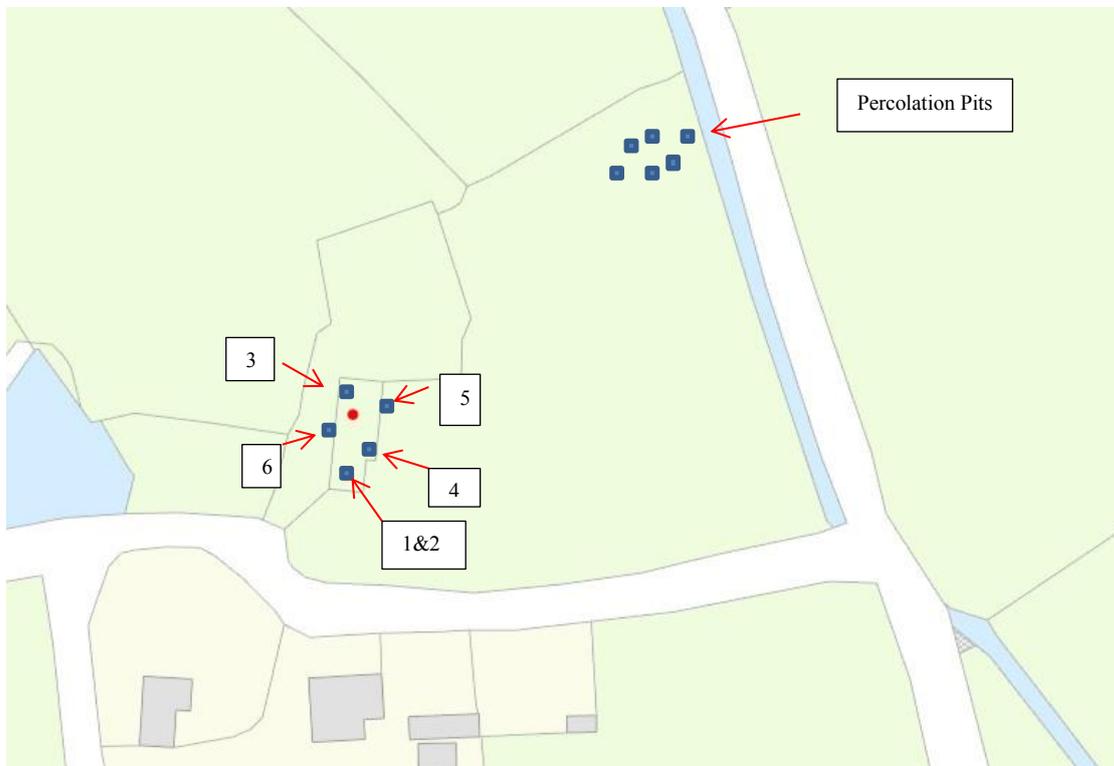
Fig. 5 Location of Test pits 1-6, and percolation pits 60m to NE of castle

Archaeological testing was undertaken on the 2<sup>nd</sup> & 3<sup>rd</sup> of November 2016 under license 16E0519. A series of 6 test pits were excavated by hand within the castle and attached house and a number of percolation test pits were excavated by mini-digger fitted with a toothless bucket at a distance of c.60m to the north-east of the castle and house (figs 4 – 6).

Six percolation pits were excavated at a distance of 60m to the north-east of the castle. All of the pits measured 2.5m in length by 1.2m in width x 0.6m deep (fig. 5; pls. 11 & 12). Probable archaeological deposits were uncovered in three of the six test pits. These deposits

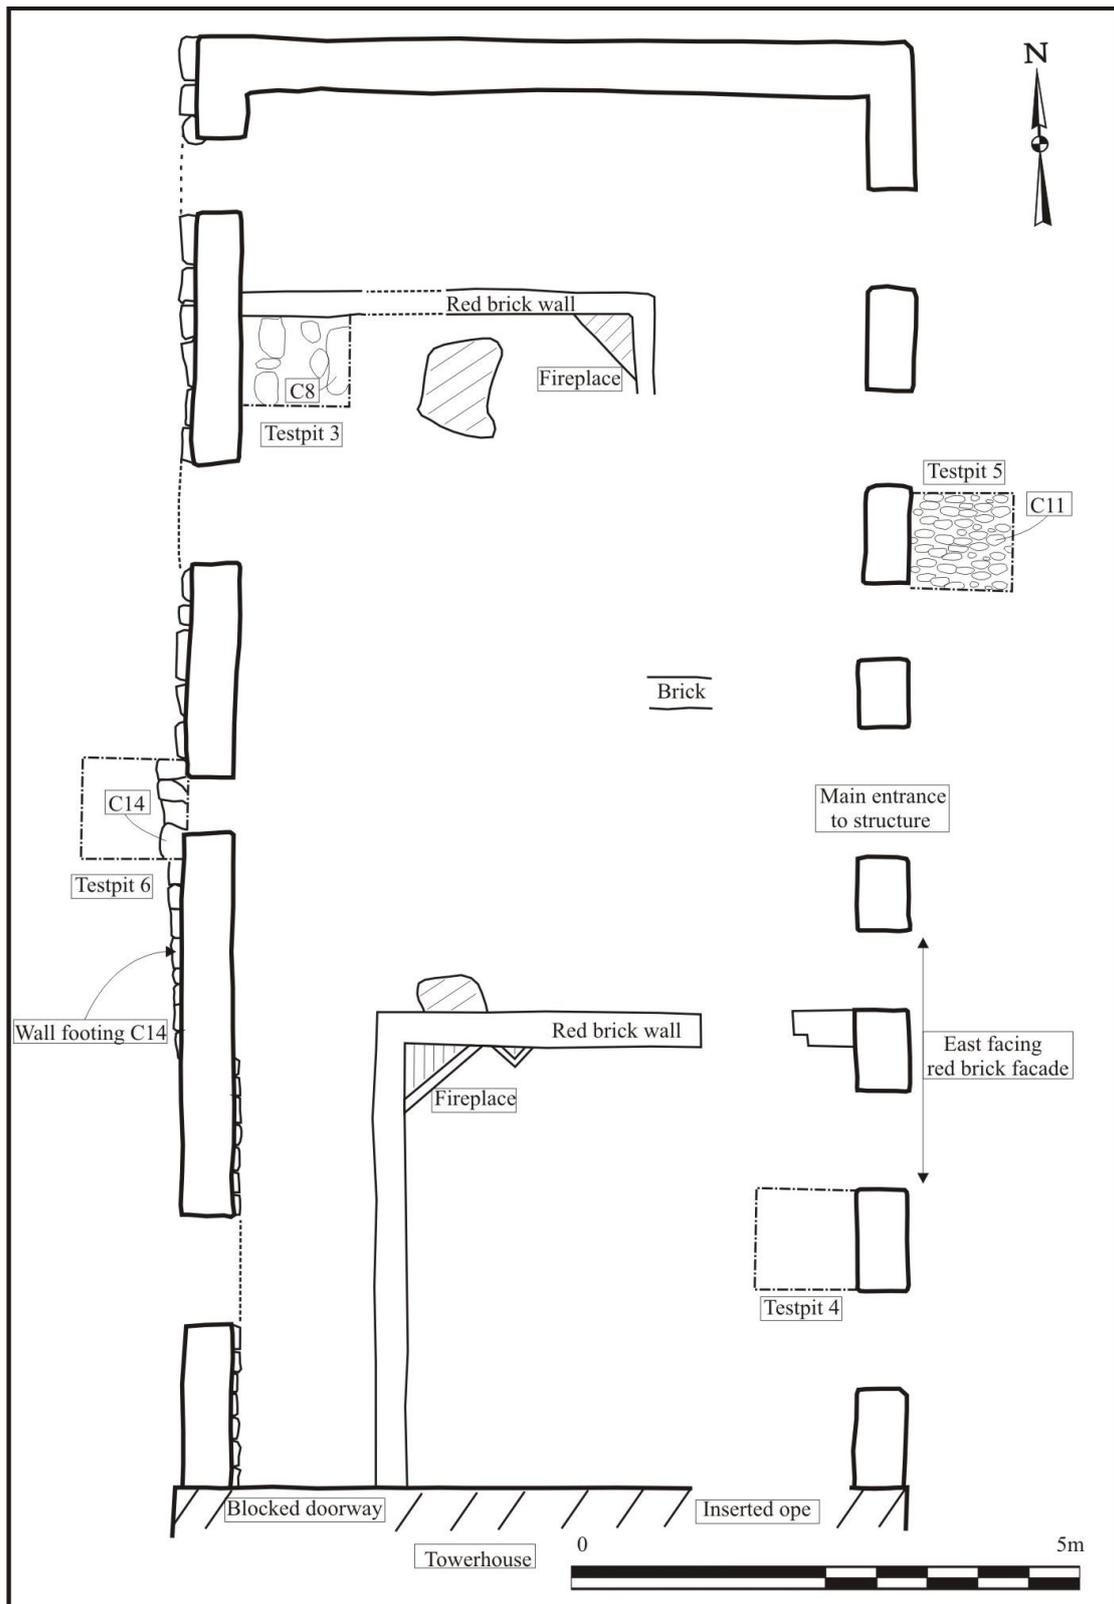
Fig. 6 Layout of attached house showing position of test pits 3-6, and location of internal features at ground level.

The interior of the house was cleared by the site owners of standing weeds prior to the archaeological assessment. This revealed other features within the house which were not evident before. The ground floor contained two distinct rooms, each with a corner fireplace made of redbrick (fig. 6; pl. 9). There is a corridor at the northern end of the house, leading to an external doorway through the western wall. There is also a corridor leading to the blocked doorway of the tower house. The tower house doorway was blocked in the 20<sup>th</sup> century. The mid-western portion of the house contained a large staircase, which is evidenced by the arrangement of openings in the western wall and the arrangement of joists on the first floor. Other footing fragments of brick walls are evident within the house and a large flat boulder is situated close to the northern fireplace. All of these features are situated at or slightly above current ground level within the building.

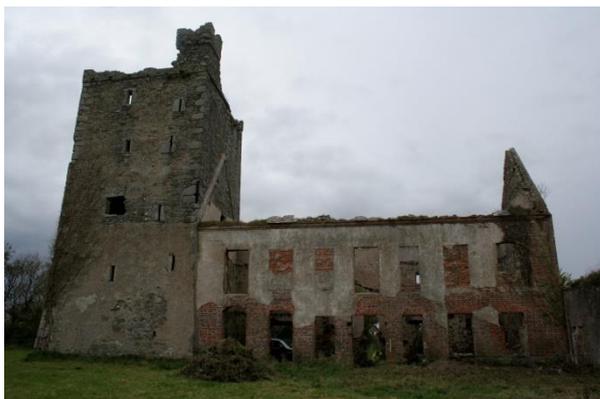
Sigginstown Castle is a rectangular tower house with external dimensions of 7.5m east to west by 7.3m north to south. The base of the walls is battered and the tower survives in good condition to wall-walk level.

Attached to the north side of the tower house is a rectangular two-storey with attic house. It has a seven-bay east-facing front constructed of red-brick, with a central doorway and three windows to either side. The western wall of the house is built of stone with brick surrounds to the doorways and windows. The scar of the roof where it joins the tower house on the north wall goes directly over one of the windows and the construction of the house rendered the machicolation ineffective.

Pl 1 Sigginstown Castle & later house

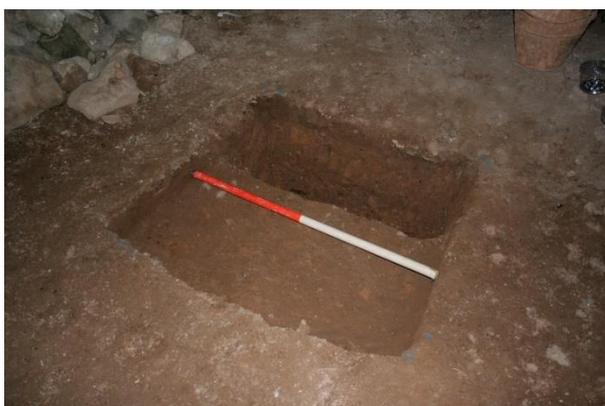
Pl 2 Test pit 1

Test pit 1 was excavated in the ground floor of the tower house. It measured 1m x 1m and was excavated to a maximum depth of 0.6m in one half of its area (pl. 2). Subsoil was not reached at this level and a piece of clay pipe stem was recovered from near the bottom. The stratigraphy uncovered consisted of:

<i>Context no:</i>	<i>Depth:</i>	<i>Description:</i>
C1	0-0.12m	Compact brown silty clay deposit with modern finds.
C2	0.12-0.60m	Relatively soft redeposited brown subsoil.

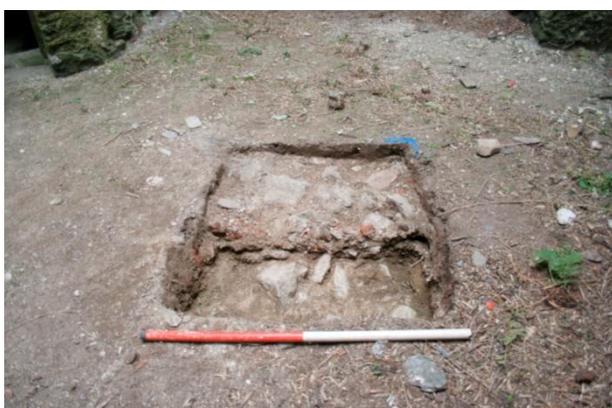
Pl 3 Test pit 2

Test pit 2 was excavated on the second floor of the towerhouse, on top of the first floor vault (pl. 3). It measured 1m x 1m and was excavated to a maximum depth of 0.3m where the top of the vault construction was uncovered. This was composed of stone set in mortar. No floor surfaces were noted.

<i>Context no:</i>	<i>Depth:</i>	<i>Description:</i>
C3	0-0.09m	Modern mixed clay deposit.
C4	0.09-0.19m	Mixed deposit of mortar, redbrick, stone, 19 <sup>th</sup> century glass.
C5	0.19-0.26m	Thin layer of sandy clay, greenish/grey in colour.
C6	0.26-0.30m	Top of vault consisting of stone set in mortar.

The test pits inside the tower house did not reveal any floor surfaces and there appears to be a build-up of late deposits on the ground floor. The test pit over the vault revealed the build-up of the vault at a depth of 0.25m.

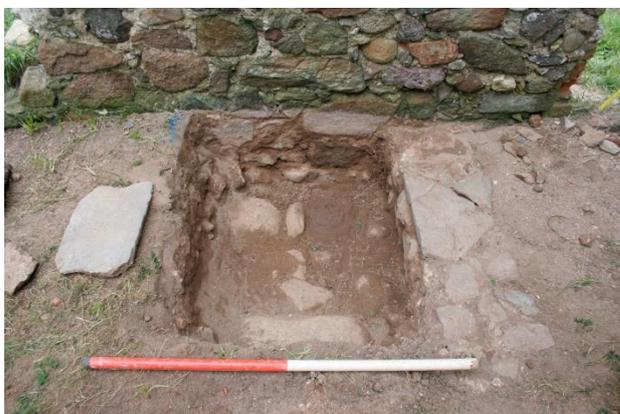
Pl 4 Test pit 3

Test pit 3 was located inside the attached house, at its northern end (pl. 4). It measured 1m x 1m and was excavated to a maximum depth of 0.27m, where a stony deposit was encountered. The foundation of the western wall of the house was observed in this trench and continued below the level excavated.

<i>Context no:</i>	<i>Depth:</i>	<i>Description:</i>
C7	0-0.27m	Grey/brown silty clay deposit.
C8	0.27m	Line of 3 stones, possibly part of a wall, oriented N-S, also a number of other stones present including a large boulder.

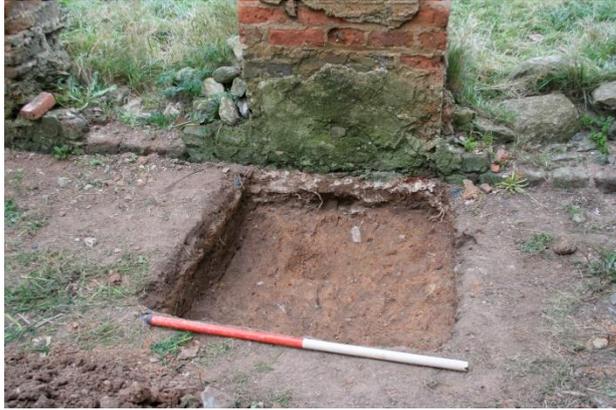
Pl 5 Test pit 4

Test pit 4 was located inside the eastern wall of the house close to the tower house (pl. 5). It measured 1m x 1m and was excavated to a maximum depth of 0.2m and subsoil was encountered throughout the pit at depths of between 0.1-0.2m. The foundations of the redbrick wall of the house were observed in this test pit to be no more than 0.1m deep and resting directly on subsoil.

<i>Context no:</i>	<i>Depth:</i>	<i>Description:</i>
C9	0-0.1 to 0.20m	Compact brown/orange clay deposit with pieces of charcoal, redbrick. Directly overlay natural orange clay subsoil.

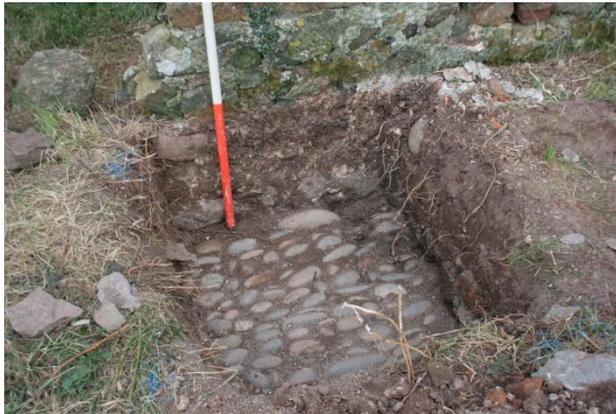
Pl 6 Test pit 5

Test pit 5 was located outside the eastern redbrick wall of the house, towards the northern end (pl. 6). It measured 1m x 1m and was excavated to a maximum depth of 0.42m where a layer of intact cobbles was uncovered. The redbrick wall continued to the depth of the excavated trench and below.

<i>Context no:</i>	<i>Depth:</i>	<i>Description:</i>
C9	0-0.42m	Loose dark brown silty clay with frequent inclusions of 19 <sup>th</sup> century glass, redbrick, mortar etc.
C10	0.42-0.46m	Layer of broken slates and mortar.
C11	0.46m	Layer of intact cobbles, average 0.1m x 0.06m in size.

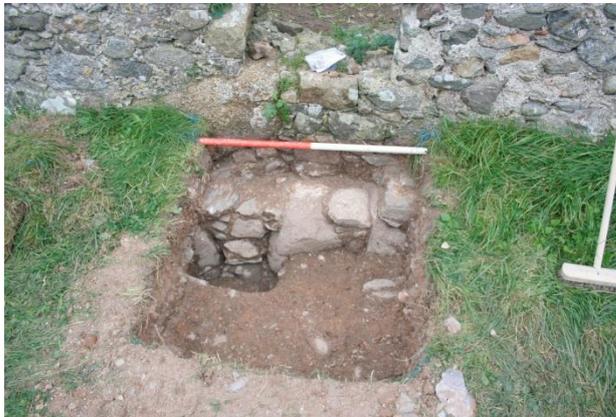
Pl 7 Test pit 6

Test pit 6 was located outside the western wall of the house and was excavated against the wall to inspect its foundations (pl. 7). The wall of the house is sitting on top of an earlier wall foundation which can be seen running the entire length of the western wall at existing ground level (pl. 8). The earlier wall appears at a slight angle to the western wall of the house and

may be tentatively interpreted as a separate feature, most likely the wall of a bawn enclosure. It measures between 0.7-0.8m in width and is composed of large stones. The western wall of the house measures 0.6m wide and the redbrick eastern wall is 0.5m wide.

<i>Context no:</i>	<i>Depth:</i>	<i>Description:</i>
C12	0-0.30m	Compact reddish brown silty clay with inclusions of redbrick, mortar and slate.
C13	0.30-0.50m	Compact reddish brown clay with flecks of charcoal, 17 <sup>th</sup> century pottery, and glass.
C14	0.46m	Wall, uncovered to a depth of 0.4m. Mix of stones sizes, stones bonded with lime mortar.

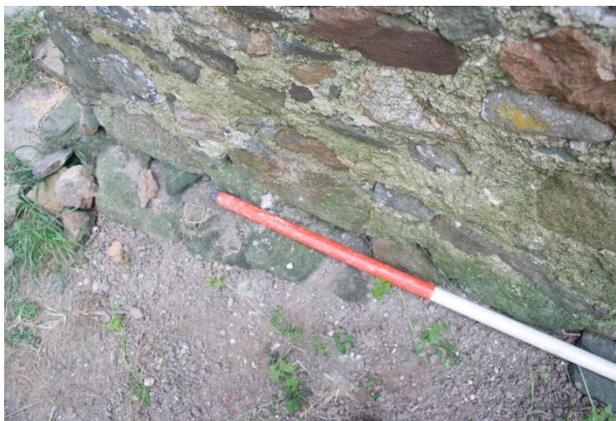
The western wall of the house is built on top of a wider, earlier wall (C14) whose footing can be seen under the western wall but not quite in a line with it, supporting the view that it is an earlier feature. This earlier wall may be the remains of a bawn wall and it is possible that the long southern wall of the adjacent agricultural building (which runs at right angles to C14) is also the remains of a bawn wall.

Pl 8 Earlier wall C14, western wall of house appears to be sitting on top of this.

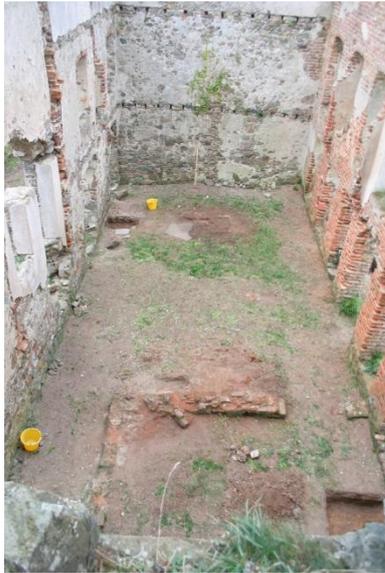
Pl 9 Interior of house showing walls and fireplaces at ground level

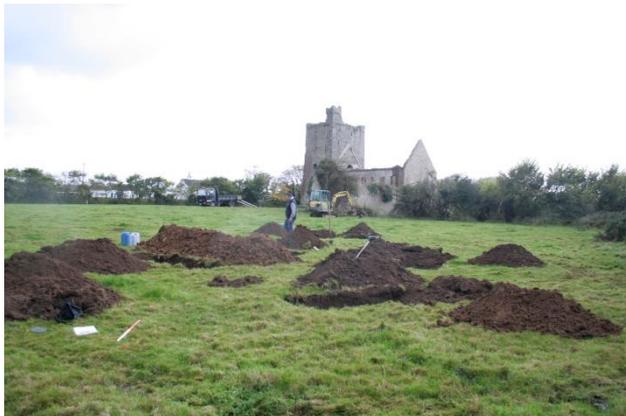
took the form of compact charcoal rich silty clays and are likely to be the remains of ditches or refuse pits associated with the castle or house. There was no impact on the identified deposits and the pits were recorded and backfilled.

Pl 11 Percolation pits to NE of castle

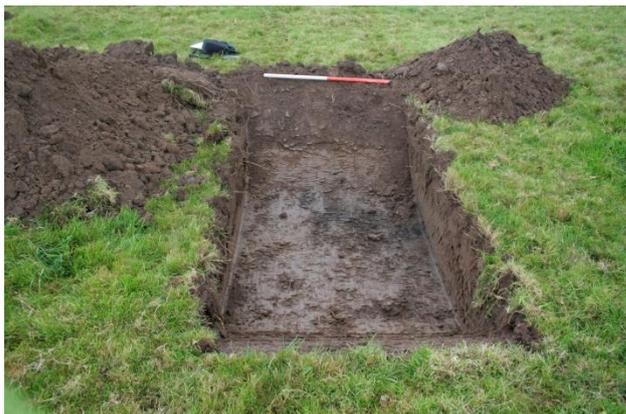
Pl 12 Percolation pit 1 with archaeological deposit in-situ
