Archaeological Assessment Report No. 2,
Sigginstown Castle, Sigginstown, Co. Wexford.

Archaeological Licence: 16E0519
Planning ref: 20180037
ITM 706253 607084
RMP ref: WX053-001 & WX053-001001

Clients:
Liz & Gordon Jones

By:
Catherine McLoughlin
August 2018

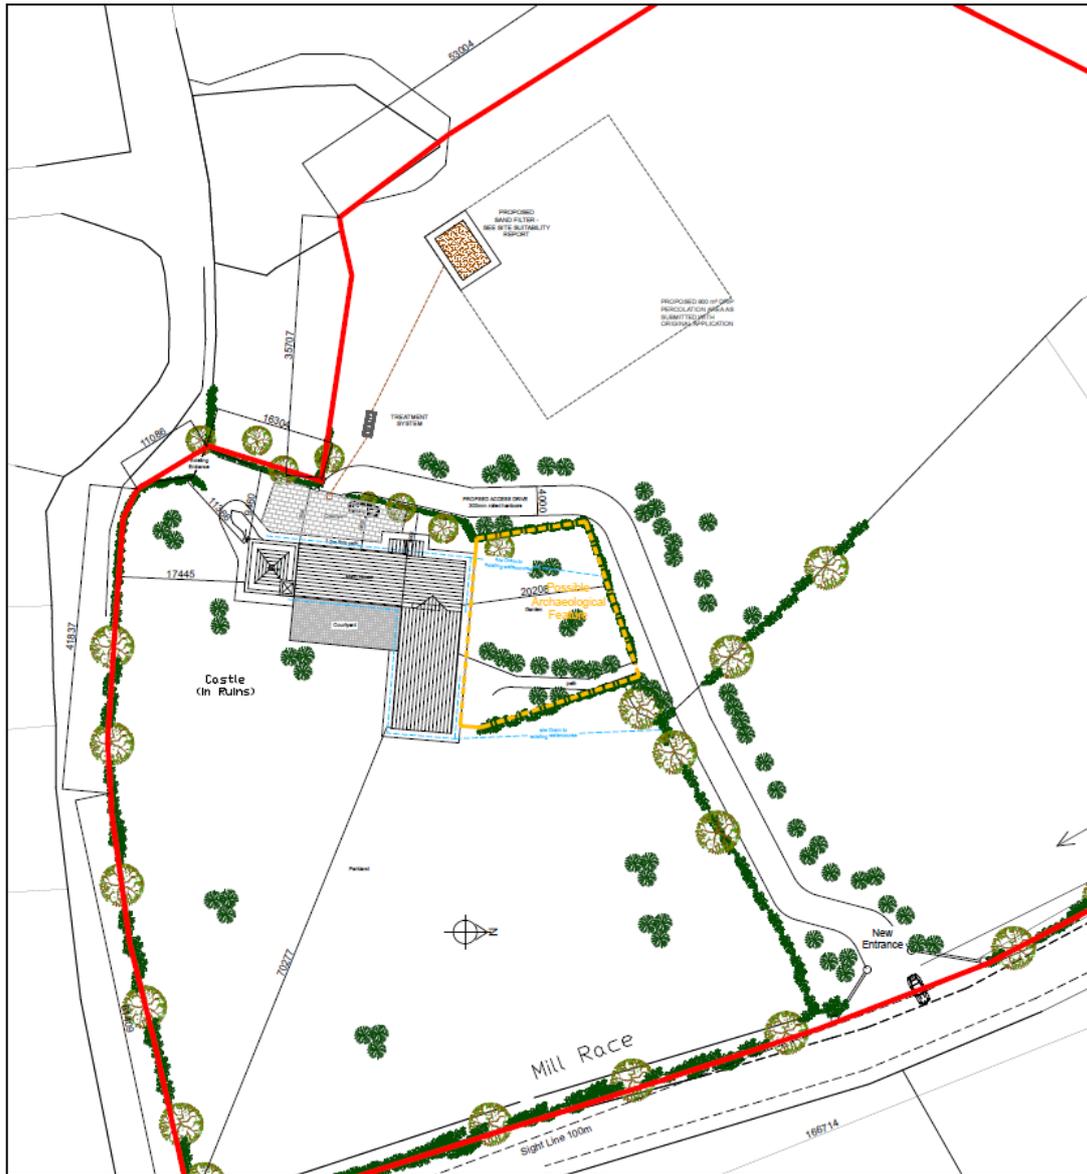
The tower-house complex is situated within a number of field boundaries which are shown on the first and second edition Ordnance Survey maps. Of note amongst these is a small rectangular area immediately to the north of the agricultural building. This is a low-lying wet area which is defined by water-filled ditches (fig. 24). It measures c. 22m east to west by 16m north to south and is defined by a low bank at the south side, the remains of a boundary visible on the first edition Ordnance Survey map. This rectangular area has been high-lighted on fig. 3 and may be of archaeological significance as a pre-tower-house enclosure.

Fig. 3 Site layout & area of possible archaeological enclosure highlighted in yellow

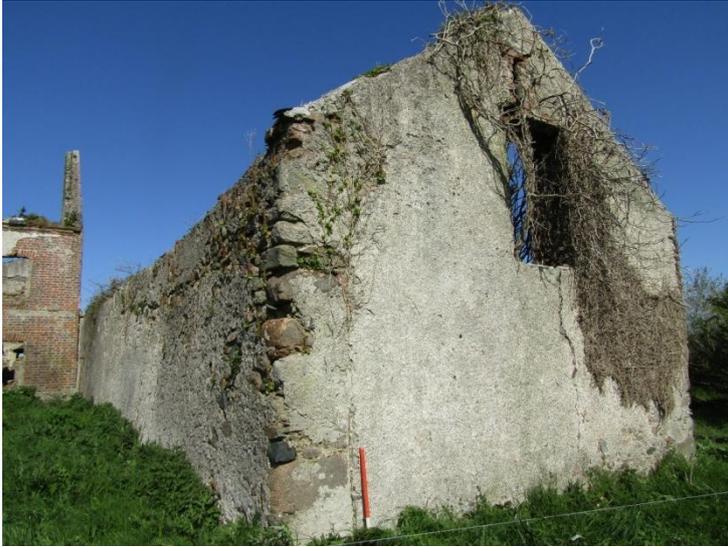
Fig. 4 Eastern gable end of agricultural building, looking W.

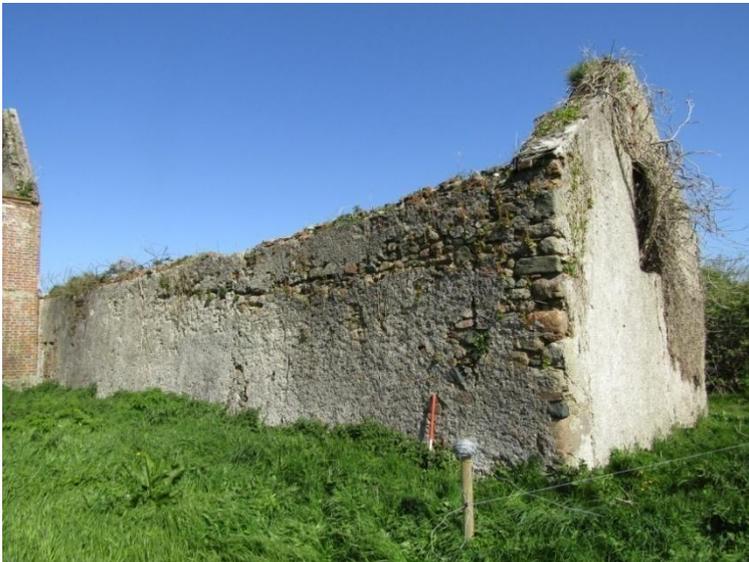
Fig. 5 South wall of agricultural building, looking NW.

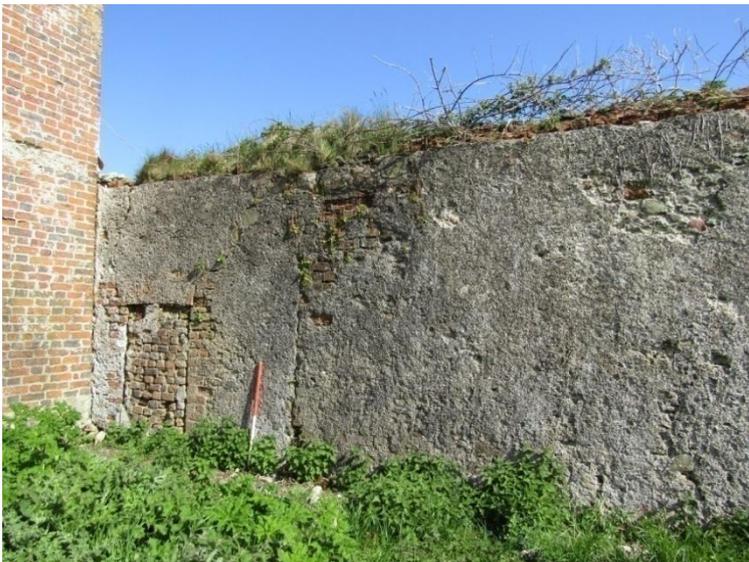
Fig. 6 West end of south wall, showing blocked doorway.

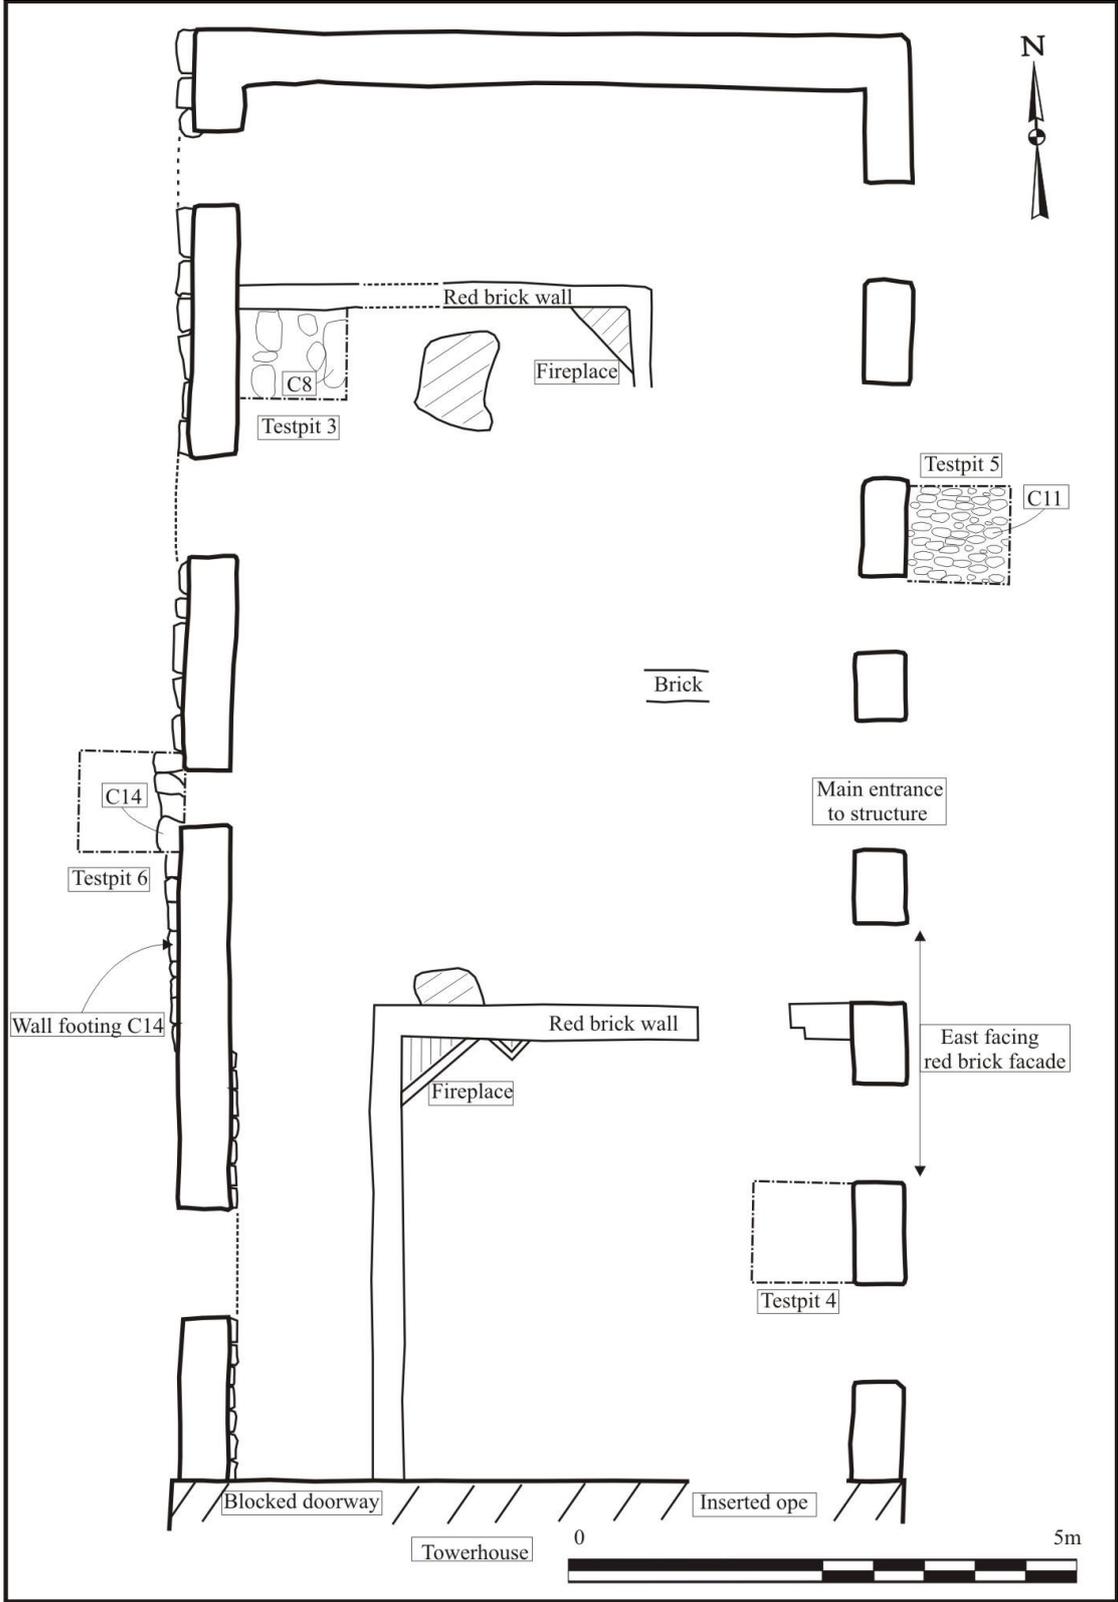
Phase 1 testing was undertaken in November 2016 and consisted of the excavation of a series of 6 hand dug test pits and a number of machine excavated percolation pits. Archaeological features and deposits were noted in the test pits and floor plan of the attached house was surveyed (fig. 7). The ground floor contained two distinct rooms, each with a corner fireplace made of redbrick. There is a corridor at the northern end of the house, leading to an external doorway through the western wall. There is also a corridor leading to the doorway of the tower house which was blocked in the 20th century. The mid-western portion of the house contained a large staircase, which is evidenced by the arrangement of openings in the western wall and the arrangement of joists on the first floor. Other footing fragments of brick walls are evident within the house and a large flat stone is situated close to the northern fireplace. All of these features are situated at or slightly above current ground level within the building.

Fig. 7 Layout of attached house showing position of test pits 3-6, and location of internal features at ground level.

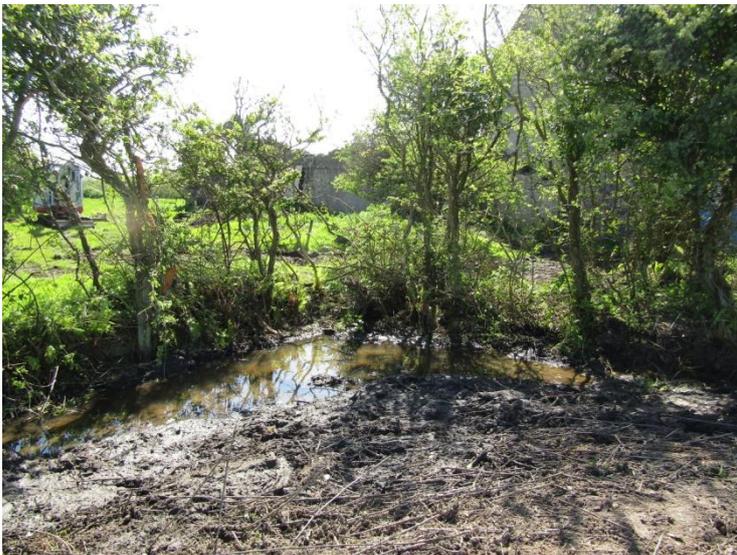
Fig. 24 Area of subrectangular field to north of agricultural building, looking SE

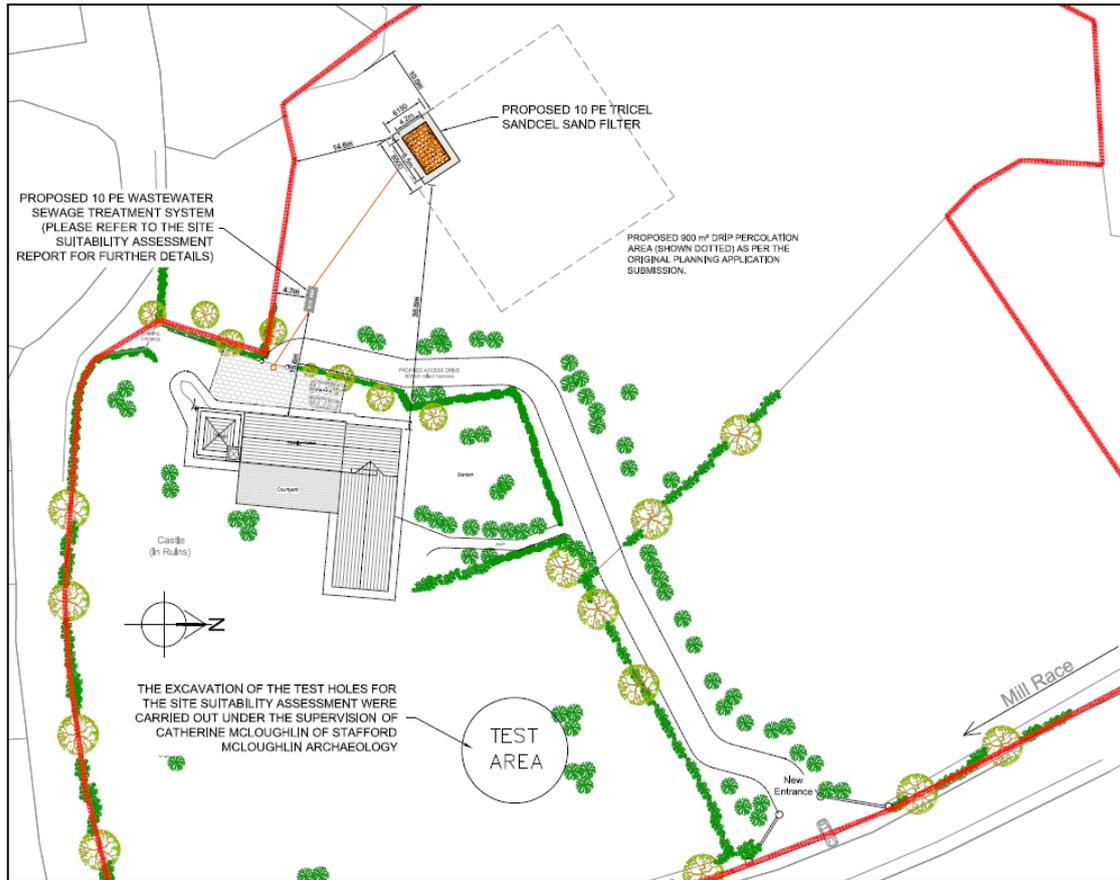
The site will also require new septic services and percolation. The original percolation pits excavated to the north-east of the tower-house complex indicated that the ground was not suitable for a conventional percolation area and so a drip system was devised which would cover a very extensive area (30m x 30m). However, a sand-cell system can be used at this site. This has a much smaller footprint than the drip system with a measurement of 8.5m by 6.15m (fig. 29).

Fig. 29 Location & layout of smaller percolation area within area excavated for larger system

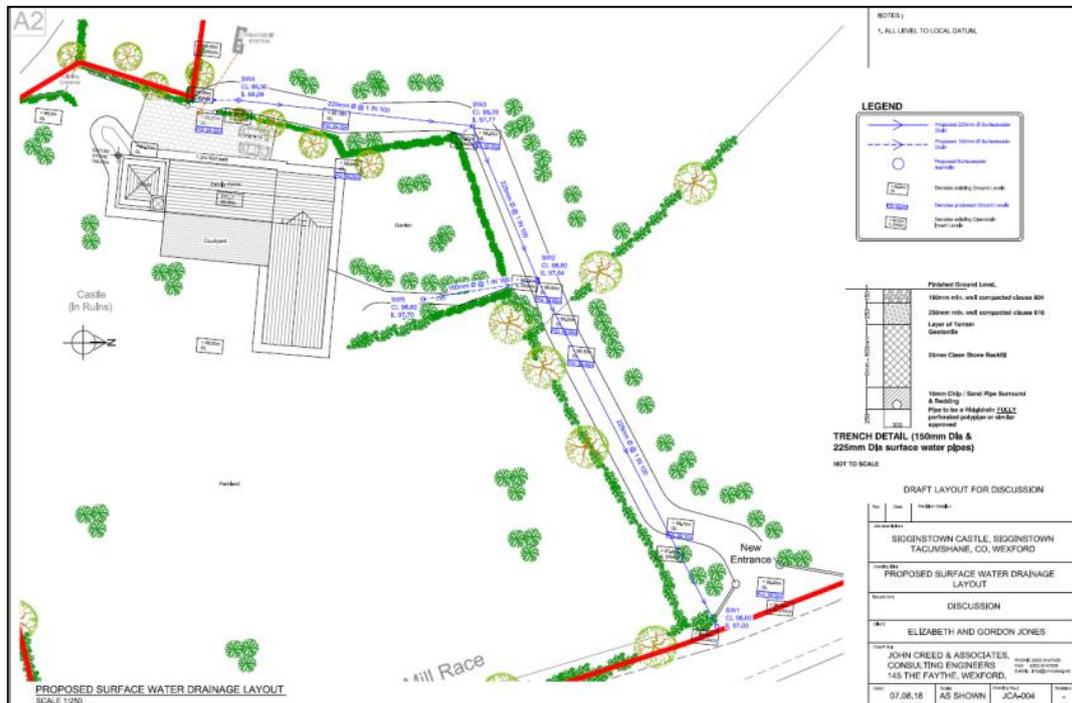
- Driveway – features and deposits are situated c.0.1-0.3m below the present ground level. In addition parts of the proposed driveway are prone to water-logging. Excavation to firm subsoil with a drainage trench is shown on the drawings therefore archaeological deposits will be impacted on (figs. 30 & 31).

- Attached house – insertion of new ground floor will require the excavation of up to 450mm of the current floor surface (fig. 30 & 32). The attached house contains internal walls and fireplace bases which will be impacted on. Underpinning of the existing walls is not proposed at this time however it must be noted that plans often change at construction stage and that underpinning may be necessary at a later stage.

Fig. 30 Location & layout of proposed drainage

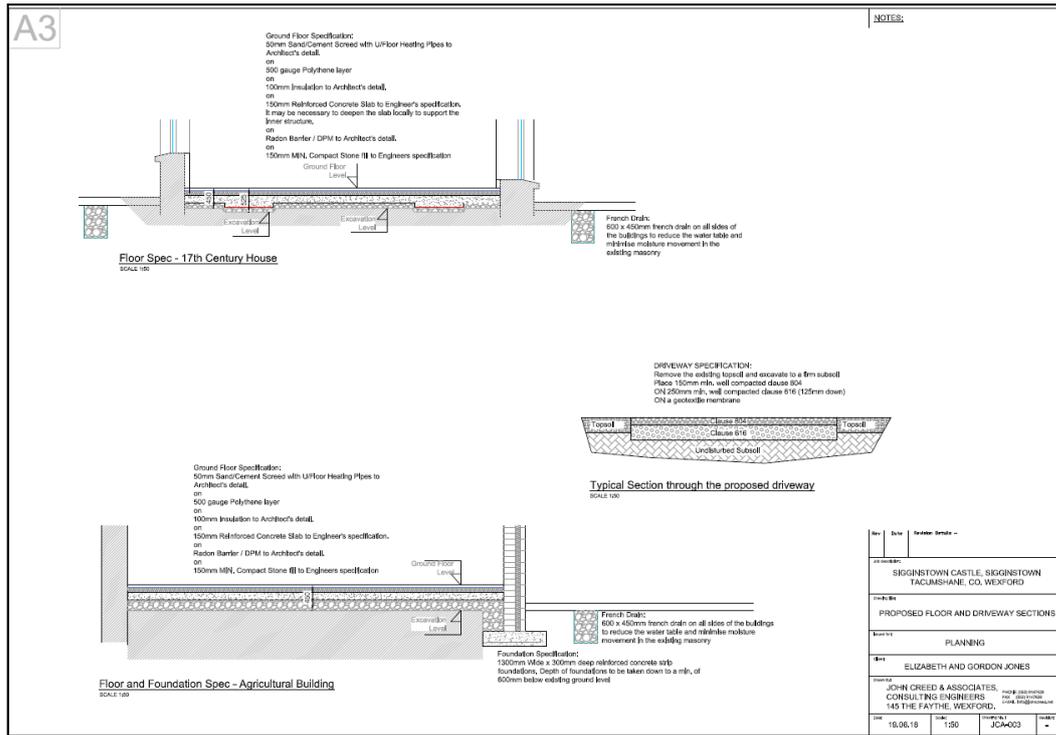
Fig. 31 Floor details and specifications

The floor specifications are shown in fig. 31. The drawings show a maximum depth of 450mm is required for the insertion of new floors. In general archaeological excavation and preservation by record is taken to the base of archaeological features and subsoil levels. However, in certain instances, it may be possible to archaeologically excavate to a certain depth, introduce a buffer zone material, and preserve *in-situ* any further archaeological features which may be situated beneath this level. Preservation *in-situ* can only be undertaken with the approval of the Department of Culture, Heritage & Gaeltacht and is dependent on knowing the nature and extent of the identified archaeological remains as well as construction details.
